Post Incident Analysis for 10109 Lorain Ave

Single Family House Fire June 29th, 2009 10109 Lorain Ave FS16's area

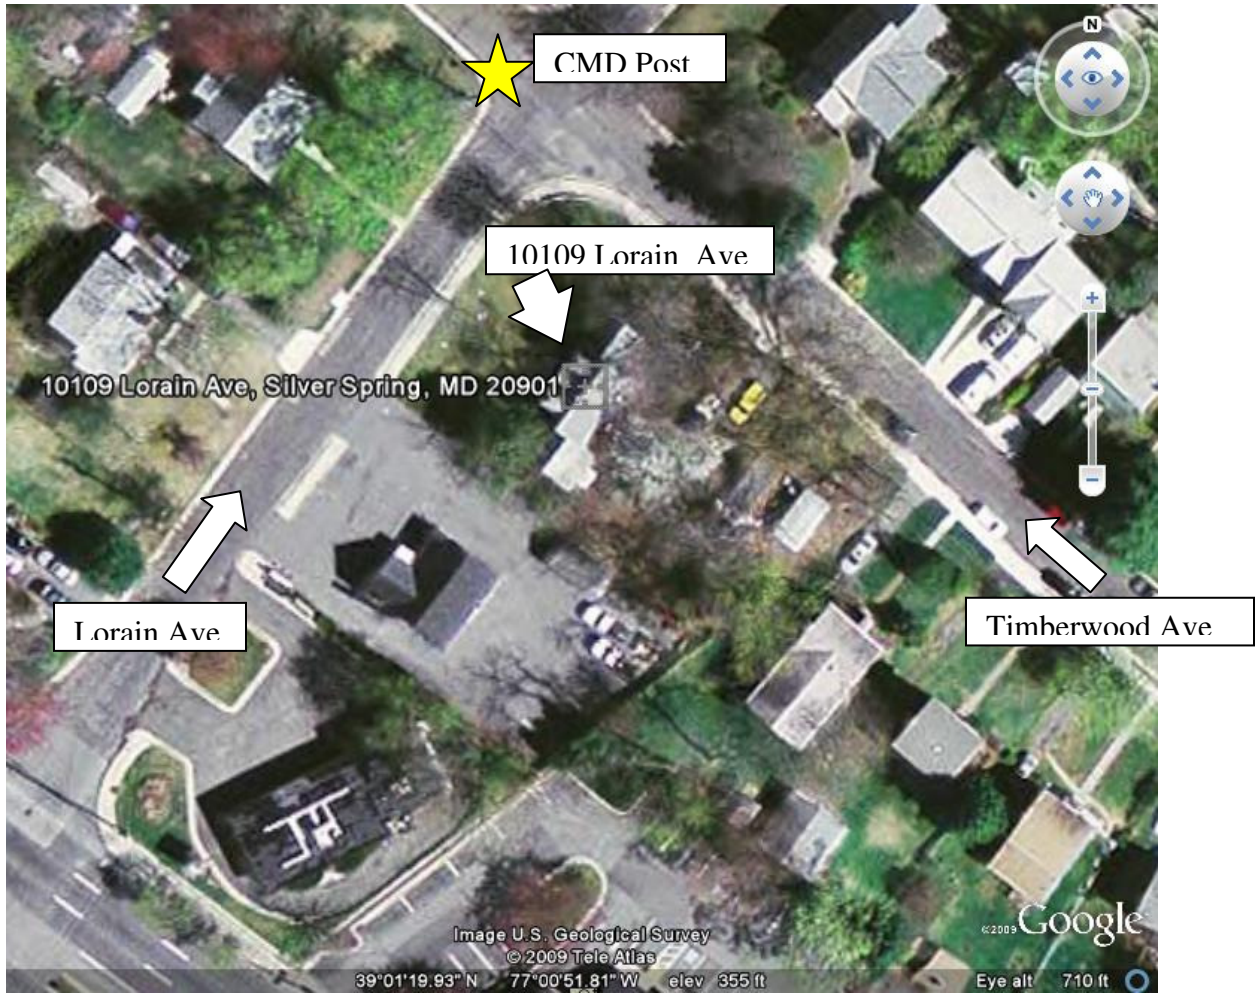
Site & Structure Layout

- Single family home on corner lot with main entrance facing side Alpha.
- Two story cape cod with basement walk out to side Charlie
- Hydrants that could be accessed with straight lays were on University Blvd W and Timberwood Ave.
- Brick and block construction with wood frame interior walls, floors, and roof.
- Building had been subdivided into three living units, each rented to separate tenants with a shared kitchen.
- The two stairways were stacked, and ran from the center of side Alpha up to the center of side Charlie.
- A wood deck was attached to the side Charlie with an entry door to the kitchen on the first floor, and exterior stairs down to the basement entry level.

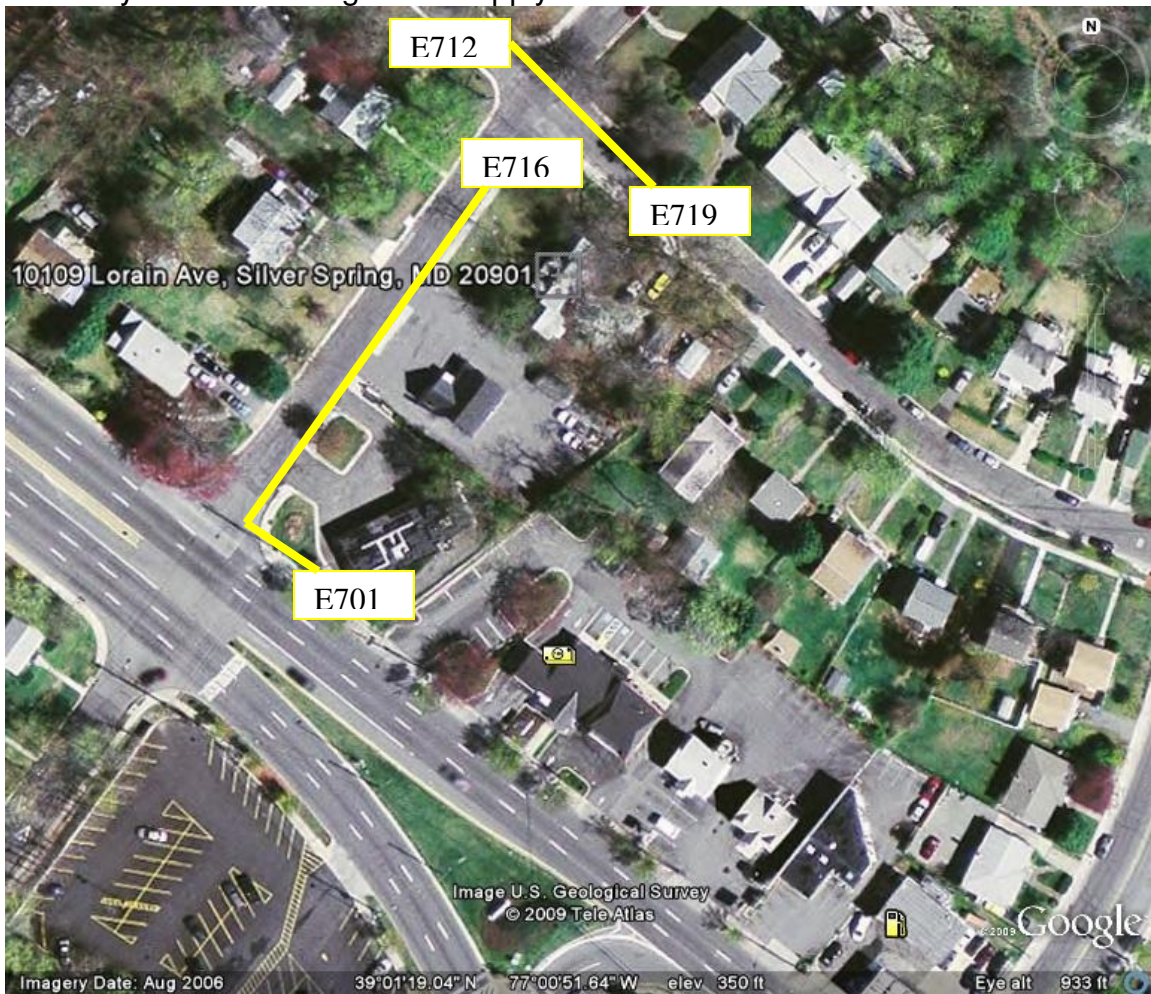
- Two hydrants were used for this incident.
- The 1st engine intended to lay out from a hydrant at 10101 Lorain Ave and announced those instructions. But due to a discrepancy in the water supply map, they hydrant was missed (the hydrant was actually located on University Blvd W). The engine driver had to “hand jack” a 4” supply line to the hydrant. The 2nd engine picked up the hydrant and charged the supply line. This correction is in progress, but it is unknown how many copies of the map with errors are in circulation.
- 3rd engine also had a discrepancy in their maps and “hand jacked” a 4” supply line to the hydrant in the 300 block of Timberwood Ave. It is

unclear what caused this discrepancy. The 4th engine positioned at that hydrant and charged the supply line.
